**Flood Control Project Maintenance
Levee Inspections****LMA District Cover Sheet****Spring 2014 Levee Inspection Results****Reclamation District No. 1660 Tisdale**

Levee Inspection Report By Mile - Spring 2014

Reclamation District No. 1660 Tisdale

Waterway	Bank	Unit Miles	Inspection Start/End	Inspector
Unit No. 01 Sacramento River	Left	3.00	04/17/2014 04/17/2014	Bob Duffey

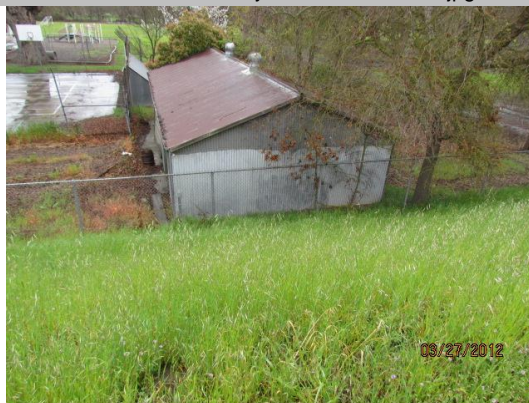
Photo 1 of 1 : rduffey_s_20140304_246.jpg

LM Start	0.05	Rating **	M	Issue No.	12
LM End	0.05	Issue Type +	En	Location *	LS
Category	Earthen Levee			GPS Latitude/Longitude	
				Start	End
Item	Encroachments			39.062643 °	39.062643 °
				-121.837857 °	-121.837857 °
DWR ID	DWR_RD1660_01_s _ 2012_12				
Action/Comments					
Building

View of the building and fence at the landside toe.

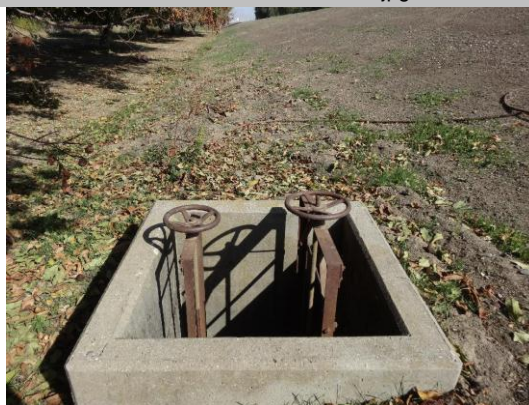
Photo 1 of 1 : UCIP_2976.jpg

LM Start	0.14	Rating **	M	Issue No.	176
LM End	0.14	Issue Type +	En	Location *	LS
Category	Supplemental			GPS Latitude/Longitude	
				Start	End
Item	DWR UCIP Field Study			39.061322 °	39.061322 °
				-121.837993 °	-121.837993 °
DWR ID	DWR_RD1660_01_s _ 2014_176				
Action/Comments					
Inspector Comments: FS_ID:22503					
EP_NO: N/A					
Repair Type:					
Crossing Status:					
UCIP Comments: - needs proper abandonment opening of landside pipe almost buried.USACE bench mark on top of headwall at landside levee toe.					
FIELD_STRUCT_DESC: Abandoned 24-inch pipe through levee, 16.4 feet below crown. Slide gate in concrete well at toe of waterward slope. (IV A-Winship). O&M Manual SAC 133, August 1955.					
FS Date: 10/10/2013

WS view: two slide gates in concrete box on levee slope.

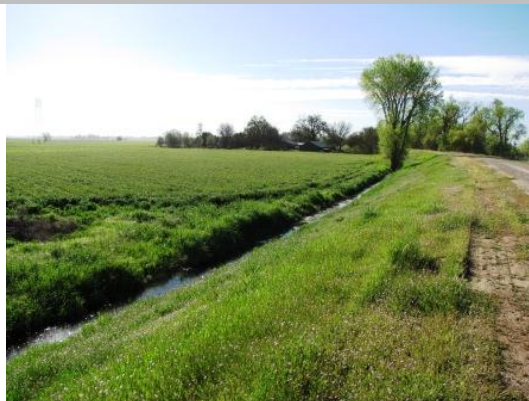
Photo 1 of 1 : rduffey_s_20140304_241.jpg

LM Start	1.12	Rating **	M	Issue No.	9
LM End	1.43	Issue Type +	En	Location *	LS
Category	Earthen Levee			GPS Latitude/Longitude	
				Start	End
Item	Encroachments			39.047610 °	39.043622 °
				-121.838802 °	-121.836445 °
DWR ID	DWR_RD1660_01_s _ 2012_9				
Action/Comments					
Ditch

View of the ag ditch along the L/S toe.

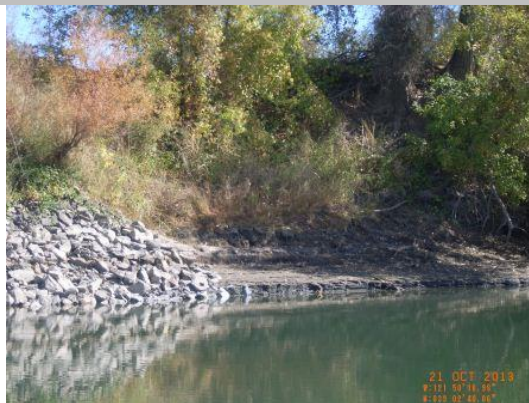
Photo 1 of 1 : USACE2013A_SAC_120-6_L_2.jpg

LM Start	1.27	Rating **	M	Issue No.	8
LM End	1.37	Issue Type +	Ma	Location *	WS
Category	Supplemental			GPS Latitude/Longitude	
				Start	End
Item	USACE Erosion Survey			39.044361 °	39.043916 °
				-121.837654 °	-121.837305 °
DWR ID					
Action/Comments					
Inspector Comments: 2009 - Erosion on levee toe where an old cobble site is failing. 2011 - Some new minor erosion. 2012 - Site extended downstream, bank is being impacted from the weight of the trees. 2013: Minor new erosion at the toe. [2013 Site ID: SAC_120-6_L]

USACE 2013 Photo #1

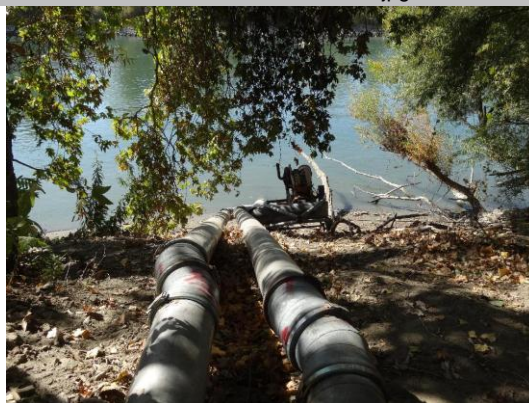
Photo 1 of 1 : UCIP_2982.jpg

LM Start	1.56	Rating **	M	Issue No.	177
LM End	1.56	Issue Type +	En	Location *	WS
Category	Supplemental			GPS Latitude/Longitude	
				Start	End
Item	DWR UCIP Field Study			39.042304 °	39.042304 °
				-121.834783 °	-121.834783 °
DWR ID	DWR_RD1660_01_s_2014_177				
Action/Comments					
Inspector Comments: FS_ID:22543					
EP_NO: 16476					
Repair Type:					
Crossing Status:					
UCIP Comments: - 16-inch old steel pipe abandoned. Abandoned pipe found on landside levee toe.abandoned power pole on waterside. mobile diesel pump on channel bank.attached tin pipes exposed on levee surface.					
FIELD_STRUCT_DESC: 14-inch steel pipe through the levee crown, the placement of two 12-inch diameter tin pipes on the surface of the levee slopes attached to the existing 14-inch steel pipe. The pipe discharges into irrigation ditch on landside. An air vent on landside shoulder. (App. No. 16476 - Ettl, 1997).					
FS Date: 10/10/2013

WS view: two exposed 12" tin pipes on levee slope. These pipes connected to the pump on river bank.

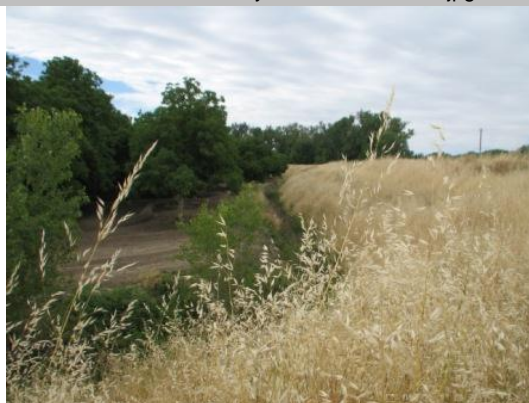
Photo 1 of 1 : rduffey_s_20140304_239.jpg

LM Start	2.04	Rating **	M	Issue No.	1
LM End	2.38	Issue Type +	En	Location *	LS
Category	Earthen Levee			GPS Latitude/Longitude	
				Start	End
Item	Encroachments			39.037640 °	39.034416 °
				-121.828421 °	-121.825698 °
DWR ID	DWR_RD1660_01_s_2012_1				
Action/Comments					
Ditch

View of the large ditch along the landside toe.

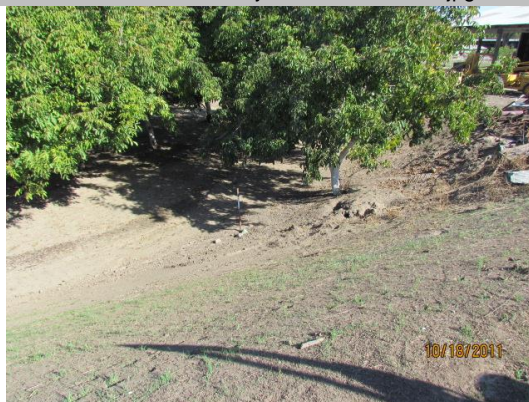
Photo 1 of 1 : rduffey_s_20140304_242.jpg

LM Start	2.62	Rating **	A/W	Issue No.	10
LM End	2.62	Issue Type +	En	Location *	LS
Category	Earthen Levee			GPS Latitude/Longitude	
				Start	End
Item	Animal Control			39.031520 °	39.031520 °
				-121.823420 °	-121.823420 °
DWR ID	DWR_RD1660_01_s _ 2012_10				
Action/Comments					
No rodents visible, but rodent burrows visible; need to backfill and compact or grout burrows.

View of rodent holes along the L/S slope.

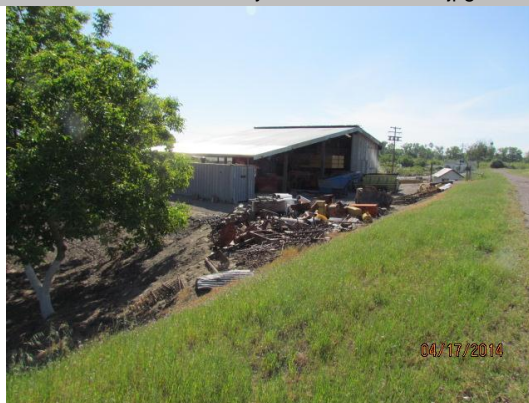
Photo 1 of 1 : rduffey_s_20140421_184.jpg

LM Start	2.63	Rating **	M	Issue No.	3
LM End	2.63	Issue Type +	Ma	Location *	LS
Category	Earthen Levee			GPS Latitude/Longitude	
				Start	End
Item	Encroachments			39.031405 °	39.031405 °
				-121.823403 °	-121.823403 °
DWR ID	DWR_RD1660_01_s _ 2012_3				
Action/Comments					
Equipment

View of equipment along the landside slope.

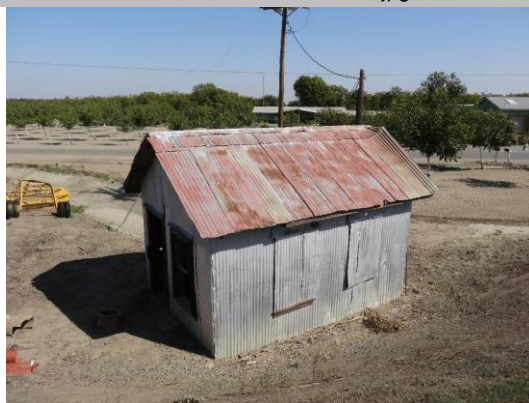
Photo 1 of 1 : UCIP_3000.jpg

LM Start	2.67	Rating **	M	Issue No.	178
LM End	2.67	Issue Type +	En	Location *	LS
Category	Supplemental			GPS Latitude/Longitude	
				Start	End
Item	DWR UCIP Field Study			39.030935 °	39.030935 °
				-121.823022 °	-121.823022 °
DWR ID	DWR_RD1660_01_s _ 2014_178				
Action/Comments

Inspector Comments: FS_ID:22632
 EP_NO: 10012
 Repair Type:
 Crossing Status:
 UCIP Comments: - abandoned pumphouse on landside toe. Needs confirmation from LMA or DWR Inspector about abandonment of pumphouse.headwall on channel bank.
 FIELD_STRUCT_DESC: 24-inch steel pipe through levee, 24 feet below crown. Slide gate on waterward shoulder. Abandoned pumphouse at landward slope. (ABO No. 10012-Harris)
 FS Date: 10/10/2013

LS view: abandoned pumphouse on levee toe.

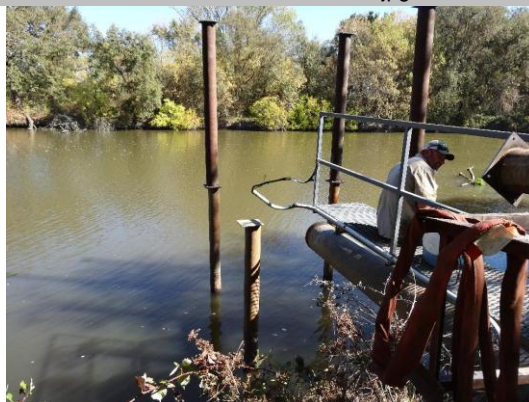
Photo 1 of 1 : UCIP_3025.jpg

LM Start	5.12	Rating **	M	Issue No.	181
LM End	5.12	Issue Type +	En	Location *	WS
Category	Supplemental			GPS Latitude/Longitude	
				Start	End
Item	DWR UCIP Field Study			39.102512 °	39.102512 °
				-121.774960 °	-121.774960 °
DWR ID	DWR_RD1660_02_s _ 2014_181				
Action/Comments					
Inspector Comments: FS_ID:22705					
EP_NO: N/A					
Repair Type:					
Crossing Status:					
UCIP Comments: Pressure relief valve on landside levee slope. Pump platform under construction for upgrade (raising platform). Look for new upgrade/revision permit.					
FIELD_STRUCT_DESC: 18-inch steel pipe through the levee, 5.8 feet below crown. Pump in channel. Gate valve on the landward berm. Discharges into 4-foot by 4 foot concrete box on the landward berm. 2-inch electric conduit through the levee, 3.0 feet below the crown.					
Application no. 4215.					
FS Date: 10/15/2013

WS view: pump platform under construction. 18" steel pipe and 2" electric conduit under steel platform.

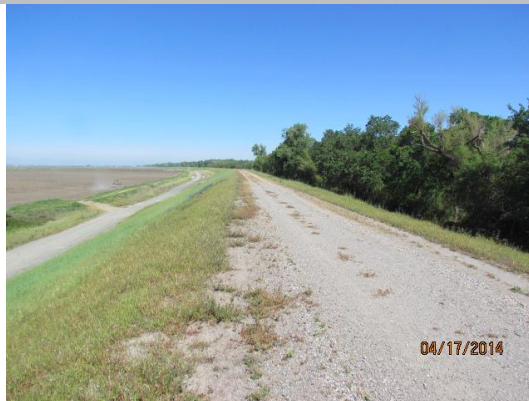
Photo 1 of 1 : rduffey_s_20140421_186.jpg

LM Start	5.13	Rating **	A	Issue No.	182
LM End	5.13	Issue Type +	Ma	Location *	LS
Category	Earthen Levee			GPS Latitude/Longitude	
				Start	End
Item	Vegetation			39.102779 °	39.102779 °
				-121.775260 °	-121.775260 °
DWR ID	DWR_RD1660_02_s _ 2014_182				
Action/Comments					
Control annual grass and weeds on the levee slopes and easements.

View of the native grasses on both slopes.
